## PROPOSED PLAN OF REMEDIAL ACTION

300 Greenhill Avenue  
Wilmington, Delaware  
DNREC Project No. DE-1433

**FIGURE 1**  
Site Location

**Figure 2**  
**Site Redevelopment Plan**  
**300 Greenhill Avenue**  
**Wilmington, Delaware**

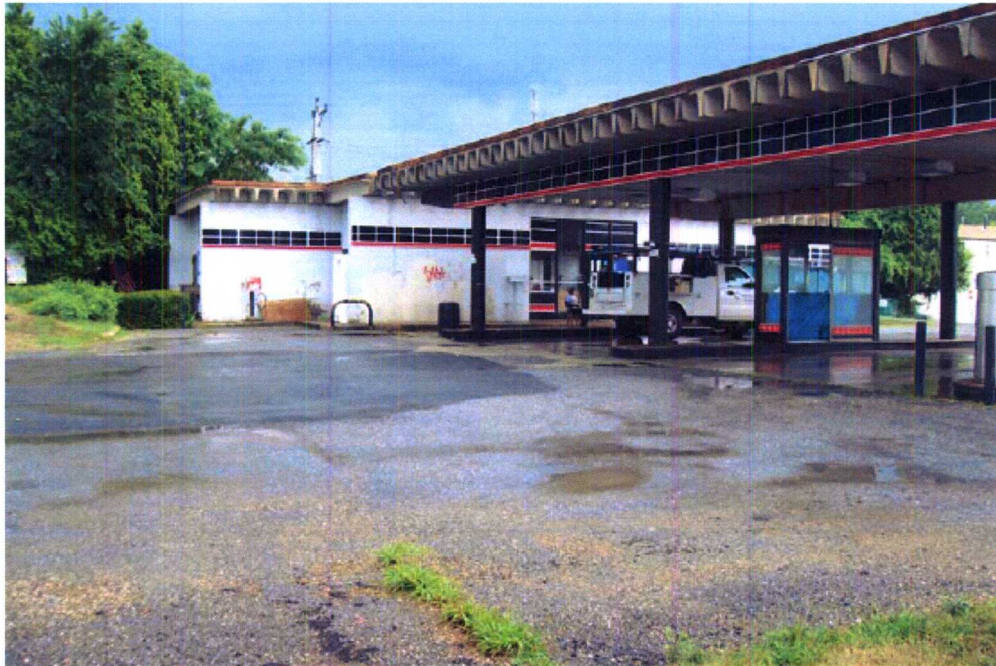
Carwash tunnel and canopy looking east before redevelopment began

The owner of the property has started to remodel the former carwash into a modern carwash facility. The remodeled carwash will include a detailing center and self-wash bays. The entire carwash works inside of the carwash tunnel will be replaced with modern carwash machinery. It is anticipated that approximately ten jobs will be created by the redevelopment.

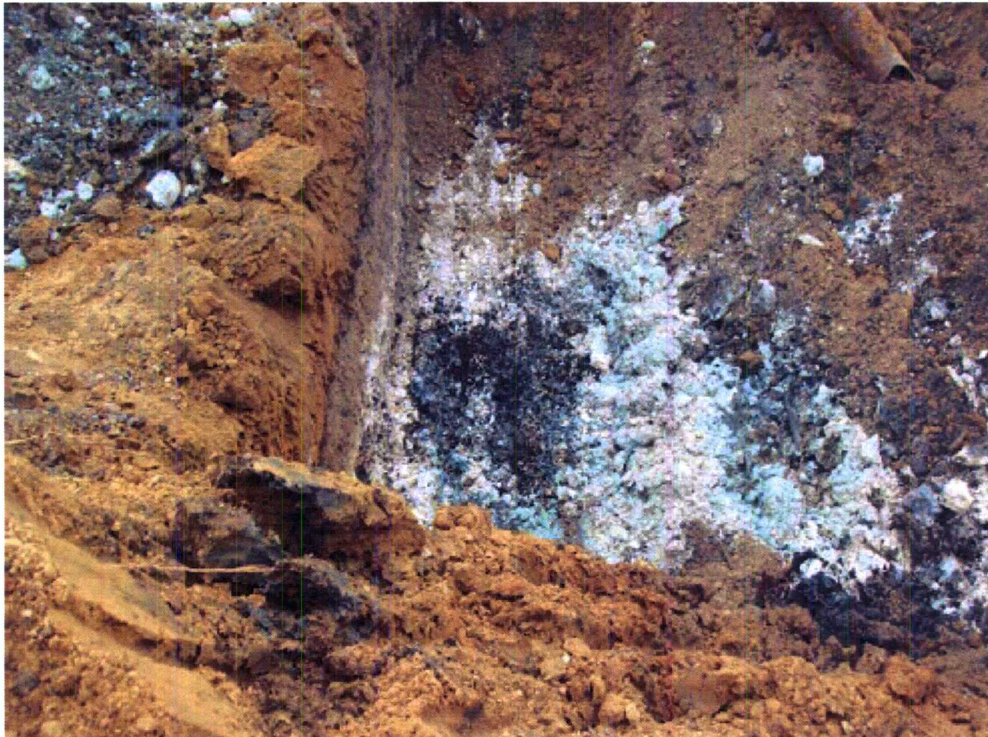
Impacted soil from the southern corner of the site containing white pasty material

The subsurface soil showed impacts as well, and one sample collected at the exit of the carwash tunnel (on the 3<sup>rd</sup> Street side of the site) contained a white-pasty material consistent with former tannery operations. The level of arsenic in this sample was above what was found throughout the rest of the site. Additional soil borings were installed and the extent of the area of white pasty material was determined. An interim action was conducted to remove all of the white pasty material from this portion of the property. During the installation of a storm drain along the 3<sup>rd</sup> Street side of the property, white arsenic material was found within 1.5 to 2 feet below the surface. As the storm drain was installed, the material was excavated to the extent of its depth, stockpiled on the site and properly disposed at a licensed facility. It was noted that this material extended under the concrete portion of the driveway exit from the property. An additional removal action was conducted to remove the white arsenic material from an area approximately 70 feet by 10 feet, under the driveway to the extent of its depth in this location, approximately seven feet.

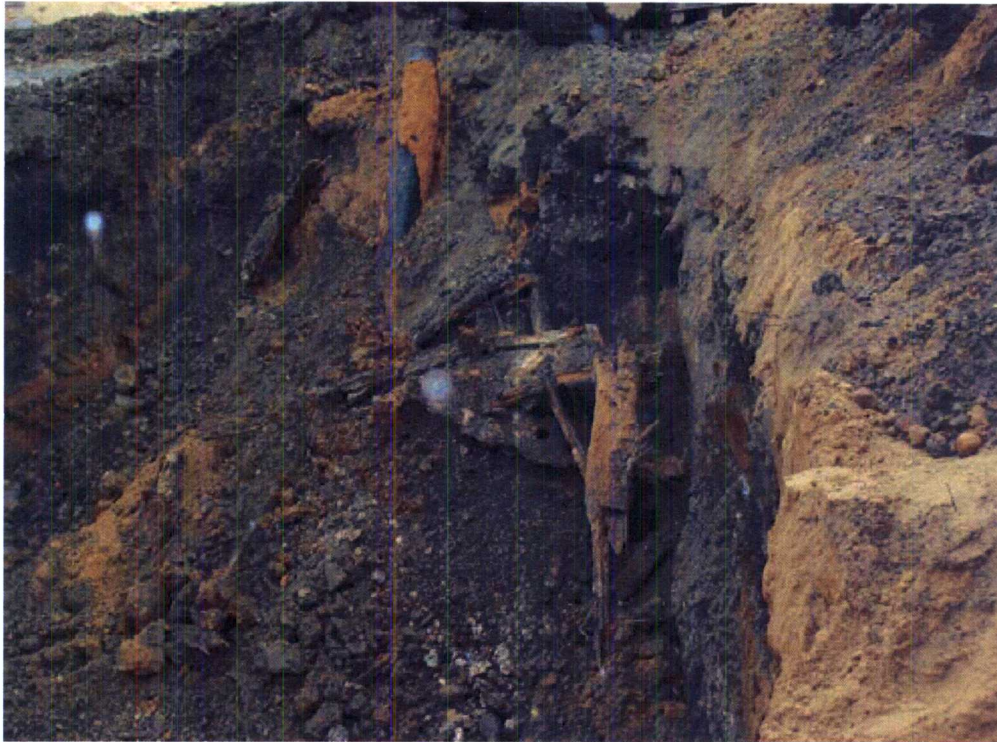
White pasty material removed from soil at southern corner of site

A total of approximately 400 tons of arsenic contaminated soil was removed from the property. In September 2008, approximately 180 tons of the arsenic impacted material observed near the carwash tunnel exit, was excavated from the site and disposed at an appropriate facility. An additional 220 tons of arsenic material was excavated from the site and disposed at a licensed disposal facility during installation of the storm drain in November 2008, and other utilities, and during an additional removal action in December 2008.

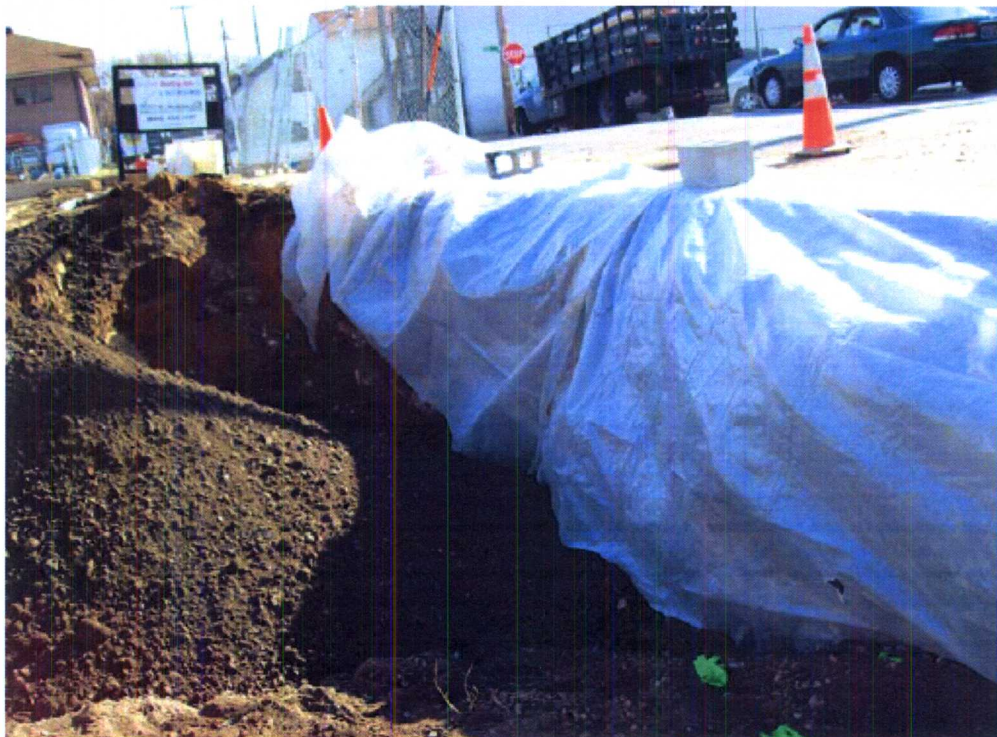
Arsenic removal area along 3<sup>rd</sup> Street being back filled with crusher run
